NBSIR 73-169

Fire Endurance Test of a Wood Stud Interdwelling Double Wall Construction

April 1973

Final Report

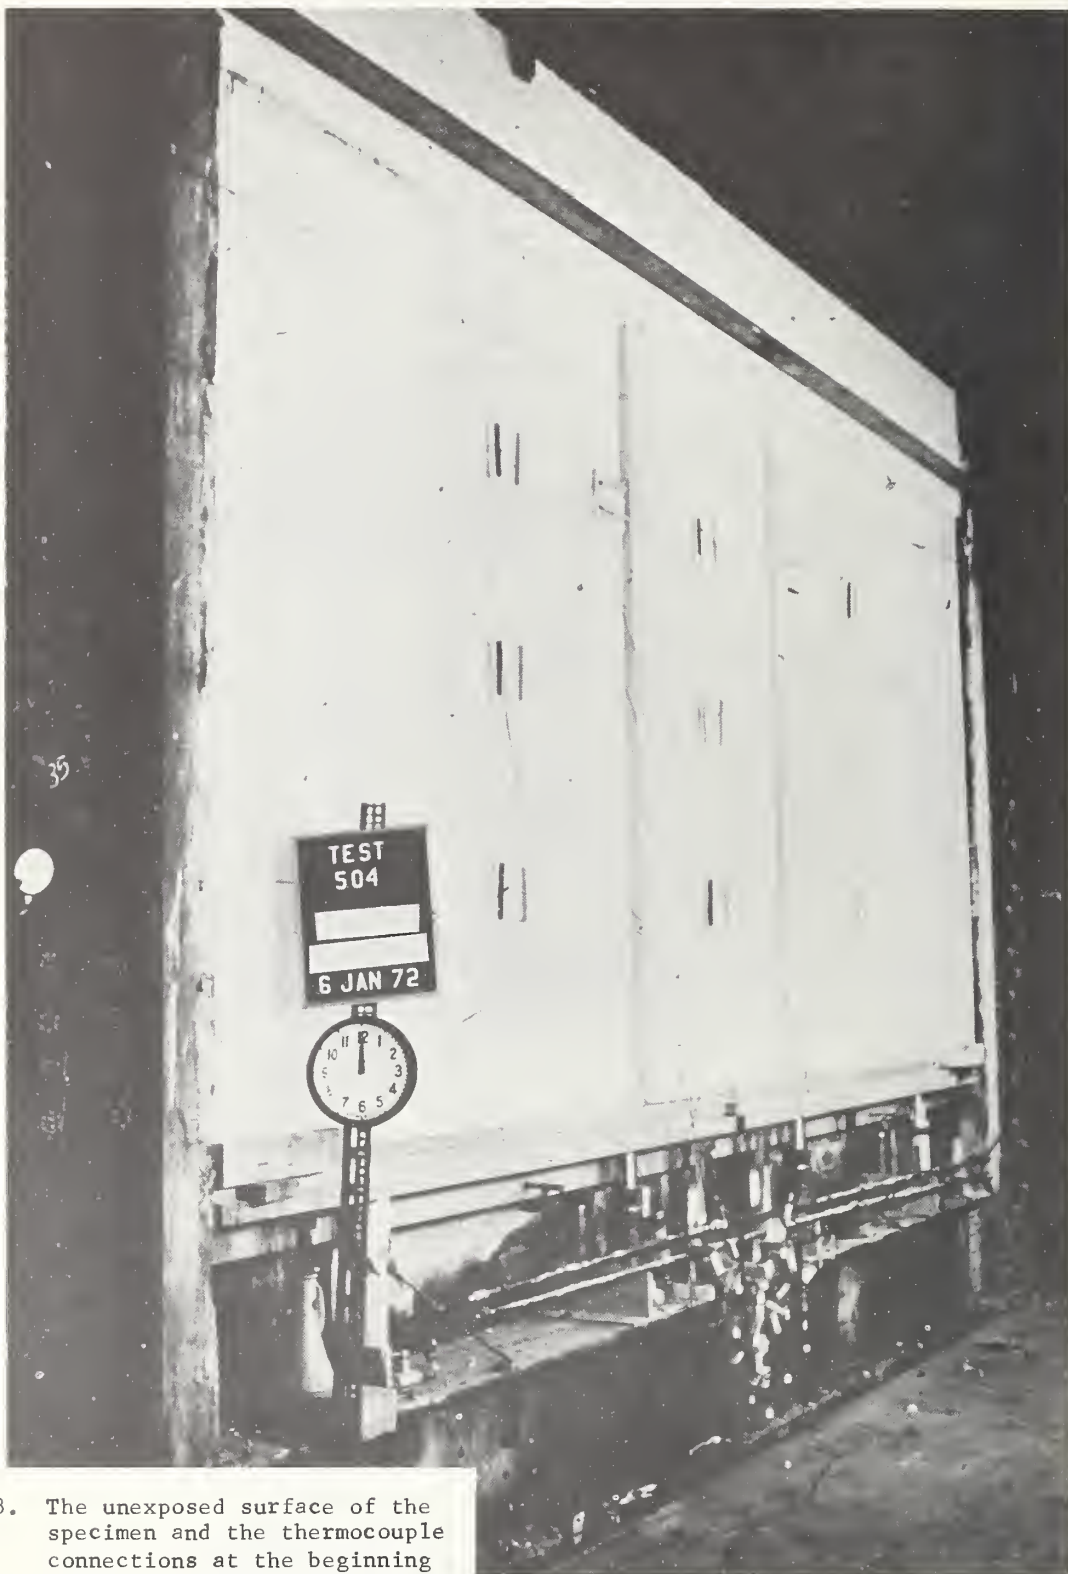
Figure 3. The unexposed surface of the specimen and the thermocouple connections at the beginning of the test. Test specimen mounted in furnace.

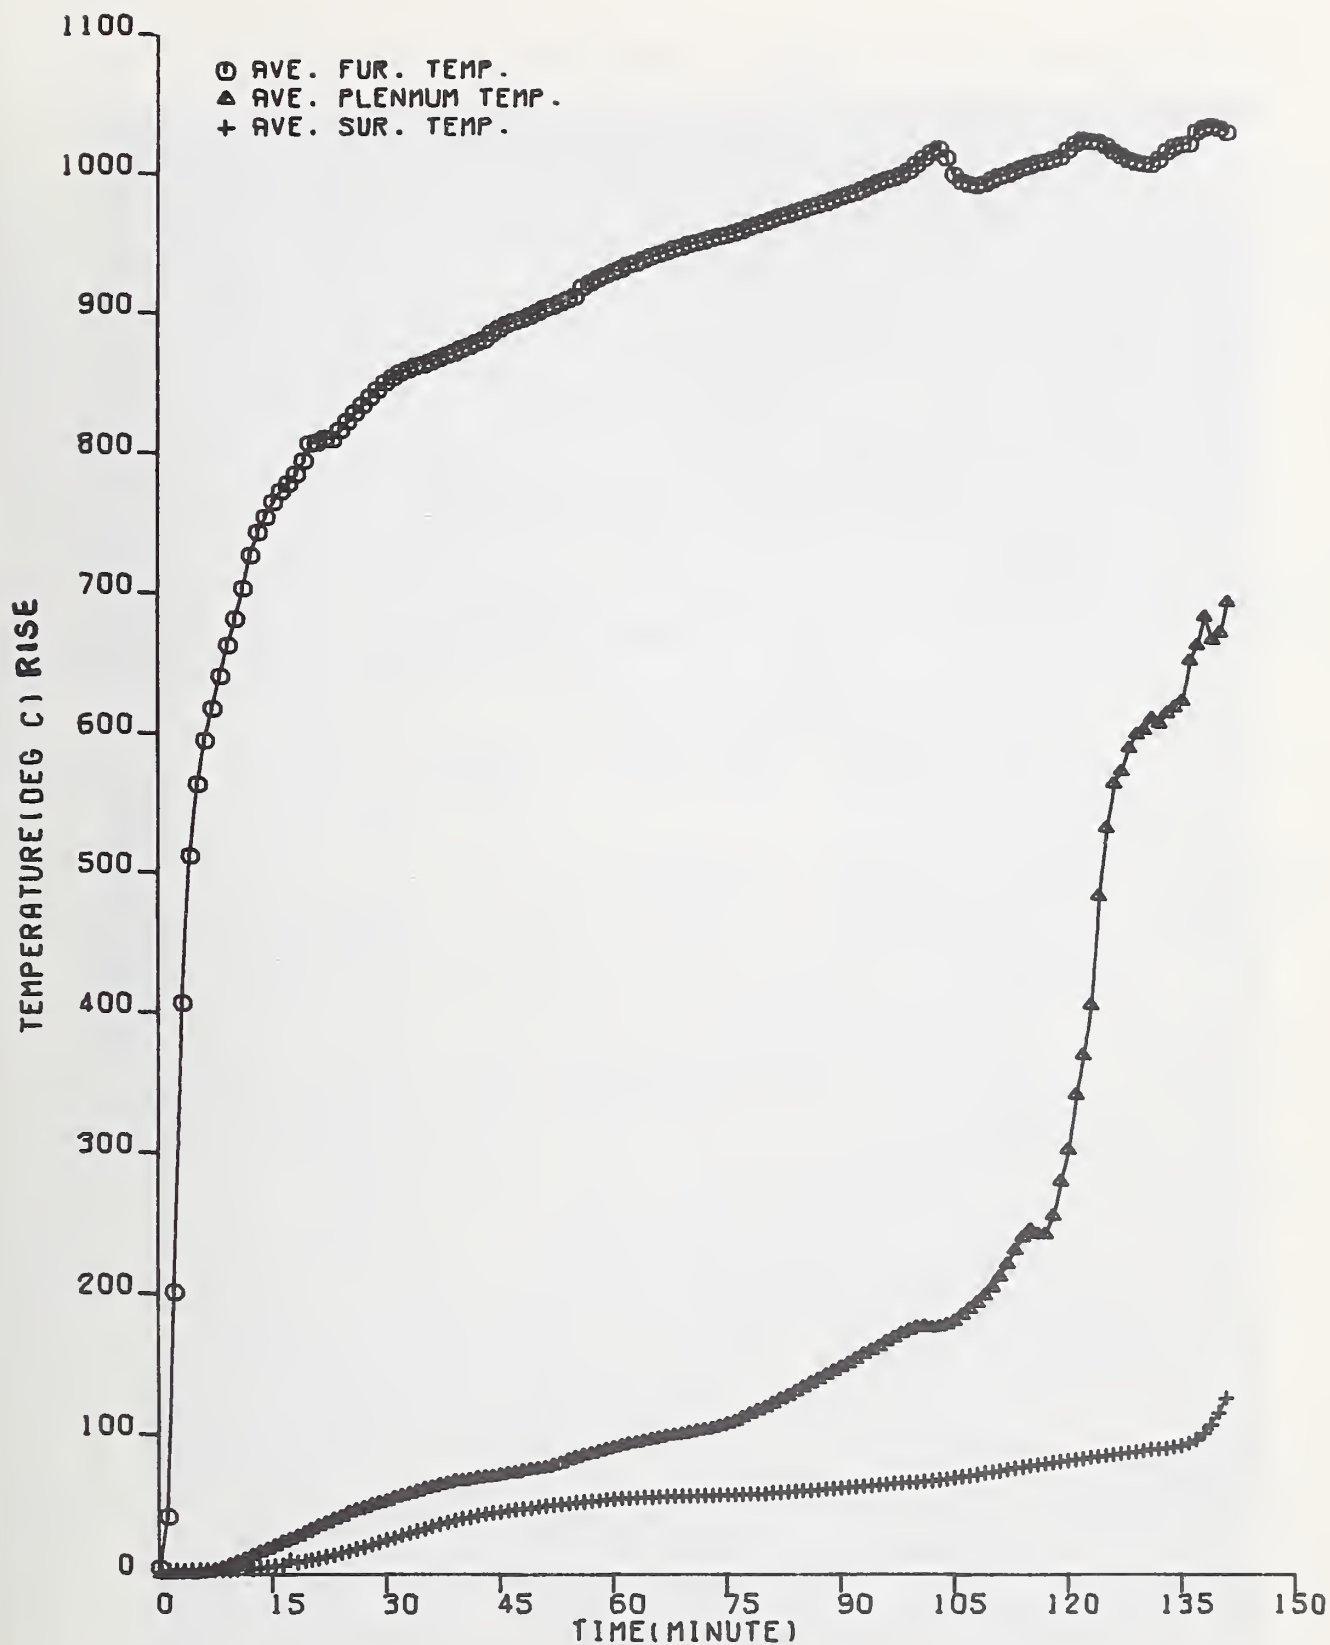
Figure 6.

AVE. AIR SPACE TEMPERATURE COMPARED WITH FURNACE TEMPERATURE AND UNEXPOSED SURFACE TEMPERATURE
